Results of Process Equipment Imaging by Tomographic Gamma Scan

Marcio I. Haraguchi^{a*}, Hae Yong Kim^b, Wilson A. P. Calvo^c

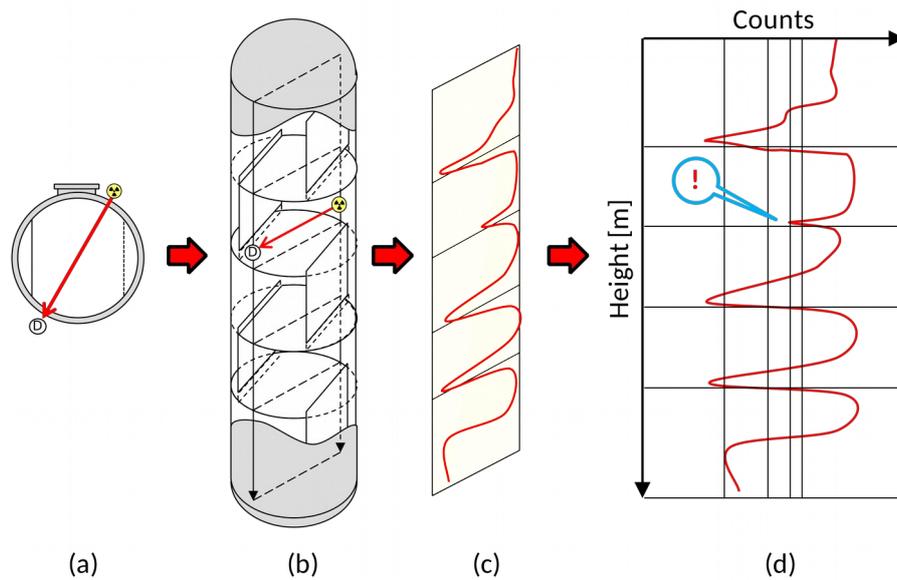
Figure 1: Typical gamma scanning process: job planning (a), field data acquisition (b), plotting (c), reporting and interpreting (d)

The main concept of the gamma scan is simple. It consists of a gamma source and radiation detector capable of moving to the same height with the aid of a positioning apparatus. An electronic interface for power supply and counting system is often connected to a computer for data storage and graphic plotting. A typical gamma scan job process is presented in Figure 1.

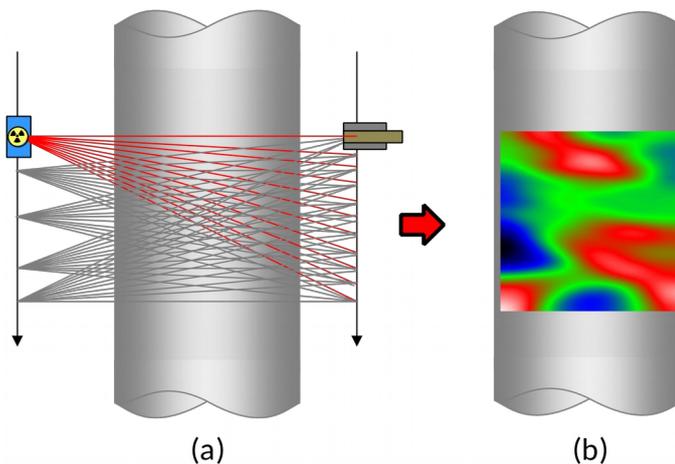
Figure 2: Tomographic Gamma Scan: Movement of source and detector and positioning scheme (a), sketch of an reconstructed image (b).

In 2012, an innovative concept (Haraguchi et al., 2012) was proposed to obtain a 2-dimensional density profile of an industrial equipment at the same vertical plane as the regular gamma scans. This proposal was part of requirements for the Master of Science program at Center of Radiation Technology (CTR) of Institute for Nuclear and Energy Research (IPEN), Brazil. This technique, shown in Figure 2, resulted in a patent deposit and Petrobras Technology Prize 2013 (in Refining and Petrochemicals category, Master Degree) was granted to the inventors.

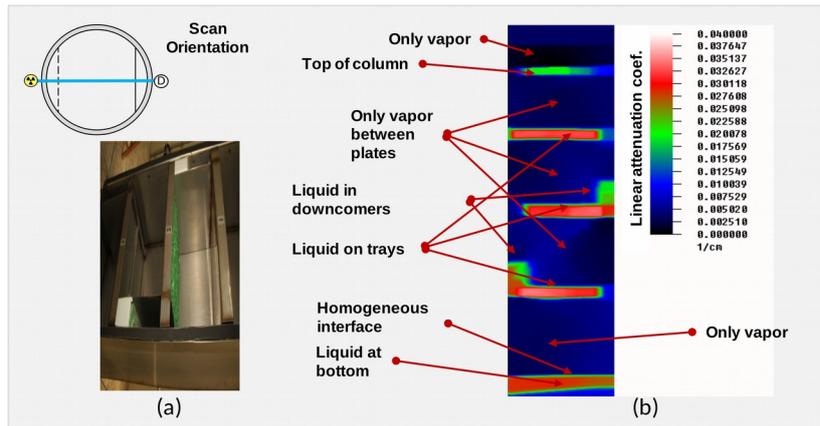
Figure 3: Trayed column model (a), image reconstructed after irradiation (b).

The concept was tested at CTR's laboratories with the irradiation of two column models designed to simulate situations difficult to be investigated with the regular gamma scan: a one-pass trayed column scanned perpendicularly through the downcomer area (Figure 3) and a random packing bed with empty areas, dense spots and unlabeled packing simulating a severe liquid maldistribution (Figure 4). Image reconstructions were done in the Signal Processing Laboratory (LPS) of Escola Politécnica, Universidade de São Paulo. To facilitate visualization, we use pseudo-colors in the density distribution images with different colors

representing different linear attenuation values. E.g.: black = air ($\mu = 68 \times 10^{-6} \text{ cm}^{-1}$), green = water ($\mu = 63 \times 10^{-3} \text{ cm}^{-1}$) and white = steel ($\mu = 420 \times 10^{-3} \text{ cm}^{-1}$).

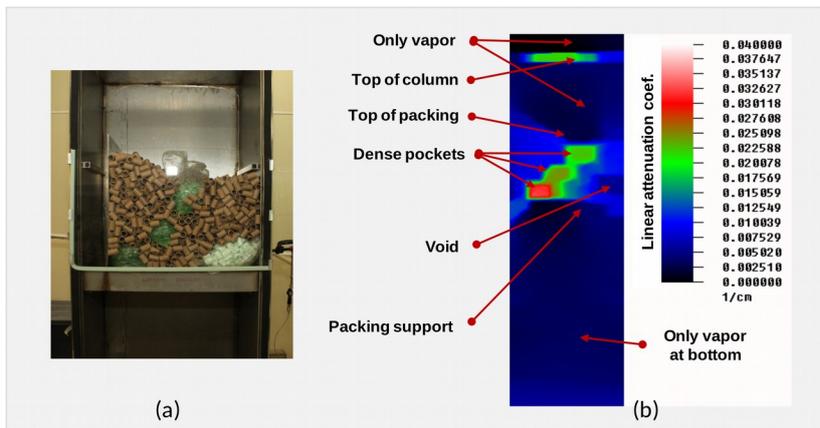
Figure 4: Packed column model (a), image reconstructed after irradiation (b).

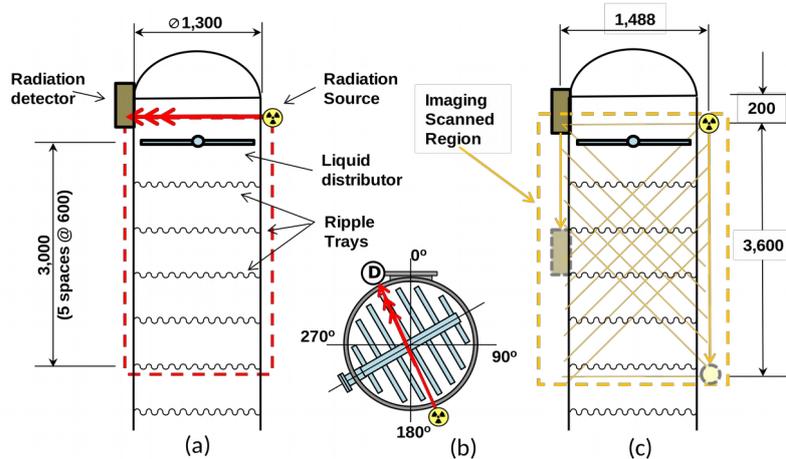
Figure 5: Top of water stripping column layout (a), conventional scan and imaging orientation (b), imaging scanned region (c).

The first tomographic gamma scanning in a real industrial equipment was carried out in a water stripping column located in a petrochemical plant in Brazil. With 1,300 mm internal diameter and equipped with 10 ripple trays as shown in Figure 5, this column has been already scanned several times with conventional technique but results could not pinpoint any specific problem to explain the operational limitations. Only the top section of the column, including a 8" diameter fish bone type liquid distributor and 6 trays, was scanned with 10 cm spacing between consecutive positions of radiation source and detector, resulting in 908 data points collected in approximately 2 hours. The tomographic scans were performed in the same direction of previous conventional gamma scanning of this equipment to allow a direct comparison.

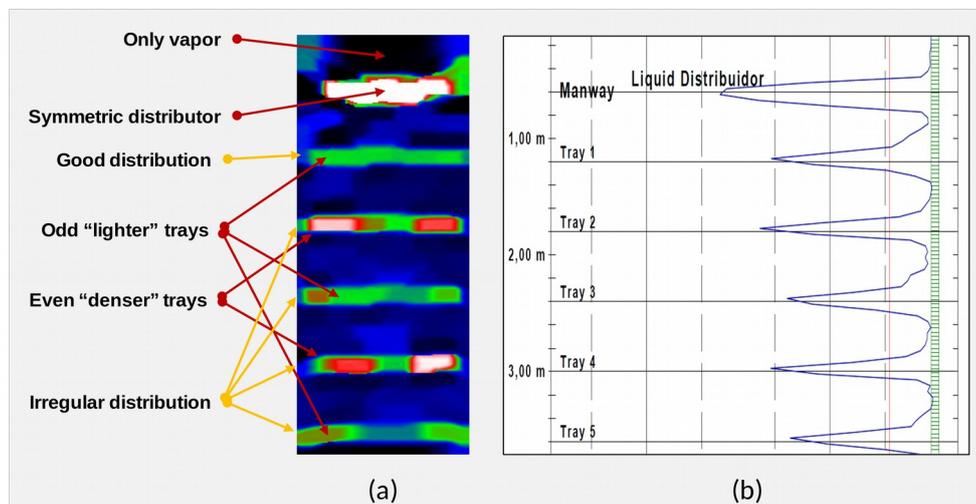
Figure 6: Imaging result (a), conventional gamma scan plot (b).

The result of the tomographic gamma scanning, shown in Figure 6, is consistent with the conventional scans. Imaging analysis should take into account the ideal operation of each internal and whether it contains, or not, liquid or aerated liquid. Any deviation from the ideal profile may indicate a mechanical or operational problem. The results of the analysis can be summarized as follows:

- The liquid distributor is in the correct place, with liquid and leveled. The scans crossed it diagonally and a symmetric shape can be seen at the corresponding elevation as expected, indicating that the central tube and lateral pipes are at their right places.
- An area of low density can be seen above the distributor, indicating that there is no liquid entrainment to the top of the column.

- Trays 1 through 5 can be seen at their appropriate elevations. The liquid in the trays seems to be leveled and there are no high densities in the spaces between trays that would indicate entrainment, flooding or other abnormal process phenomena.

- Even numbered ripple trays seem to be denser than odd numbered ones as indicated on both tomographic and conventional gamma scans. Ripple tray assembling explains the difference as even numbered trays are mounted 90 degrees shifted in relation to odd numbered trays. In fact, gamma rays cross even ripple trays transversely, hitting the metals of all tray ripples, while they pass almost parallel to the odd tray ripples, hitting mostly aerated liquid.

- The tomographic gamma scan seems to indicate a problem that has never been detected in any previous inspections of this column using conventional gamma scans: trays appear to be lighter at the center of the deck. Notice that tray number 1, right below the distributor, showed a homogeneous distribution. Maldistribution of liquid on the trays may cause this phenomenon, a problem that may occur in ripple trays probably due to different vapor velocities across the trays. Concentric maldistribution of liquid is very difficult to be detected with regular gamma scans.

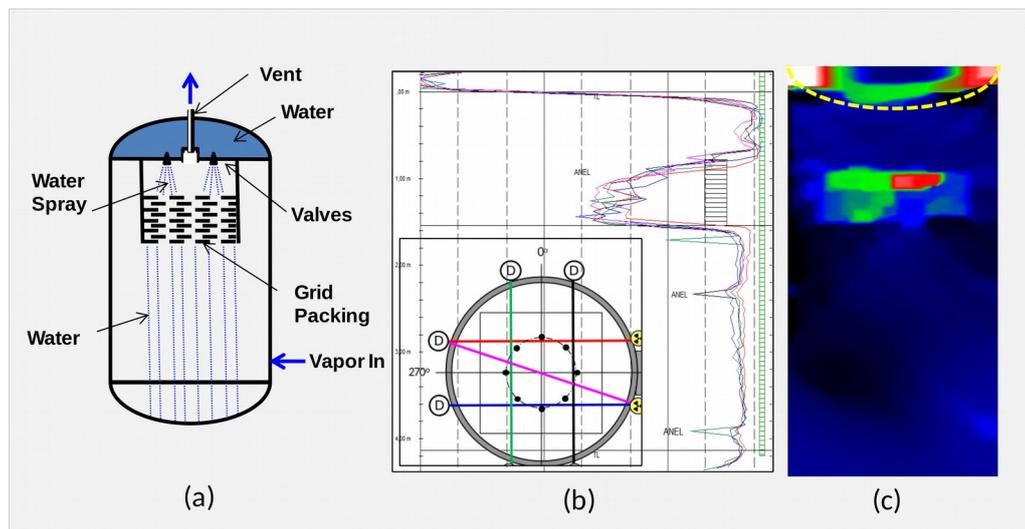
Figure 7: Deaerator sketch (a), conventional gamma scan orientation and plot (b), density profile obtained by tomographic gamma scan (c).

A 2,400 mm internal diameter deaerator of another petrochemical plant in Brazil, was experiencing poor performance with water being carried over though the vent nozzle. The vessel was scanned with 10 cm spacing between consecutive positions for radiation source and detector, resulting in 1,371 data points collected in approximately 3,5 hours. The tomographic scans were performed in the same position as the conventional gamma scanning of this equipment (red line) to allow a direct comparison.

Regular gamma scans indicated no signs of flooding or excess entrainment. Although the grid packing doesn't show a consistent height and profile as it would be expected, not much more information could be gathered from the data. Imaging results match the findings of the gamma scans but also revealed more about the grid packing:

- Density distribution is very inconsistent at the grid packing, with a dense spot appearing at the top right (red zone), an intermediate density (probably liquid) on the left side (green region) and a low density region (probably dry grid packing) appearing just beneath the dense spot.

- It does appear that a dense and flat object is blocking the liquid flow at the top of the grid packing.
- The top and bottom limits (yellow dotted area) of the image have reconstruction limitations due to the lack of scanning data in this region.
- The imaging data doesn't reveal the origin of water being carried over with the vapor through the vent.
- Customer decided to live with the problem until a shutdown opportunity arises.
